Friendly Inspection Services

Property Inspection Report

Single family residence 1920s
Inspection prepared for: Sample Report
Date of Inspection: 4/22/2015
Age of Home: 1920
Weather: Sunny, 43 degrees
Sample report
1920s Building

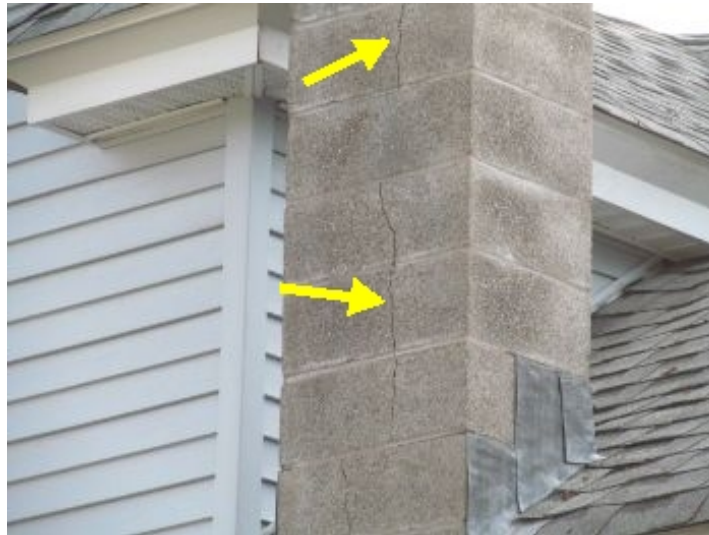
Chimney type: Block
Cracked block observed, unable to view flue tiles because of debris in clean out. • Further investigation recommended, if chimney is to be used it should be checked by a chimney sweep or mason contractor

Cracked block observed

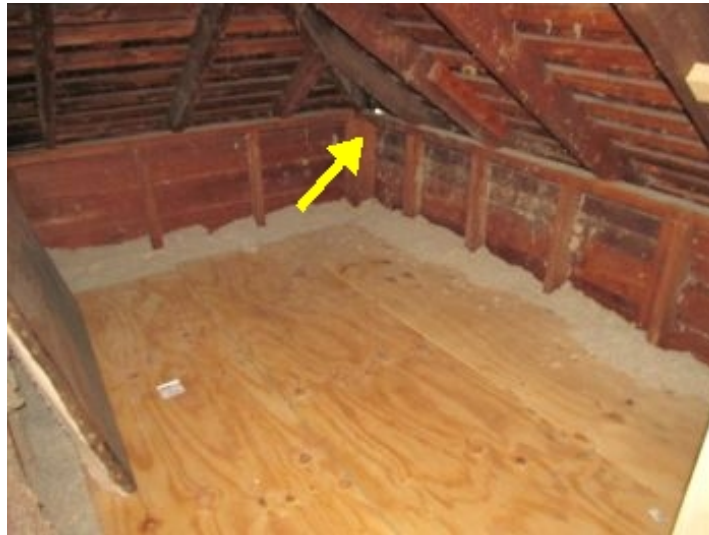
Gap in fascia observed through attic access, this should be corrected to prevent rodent entry

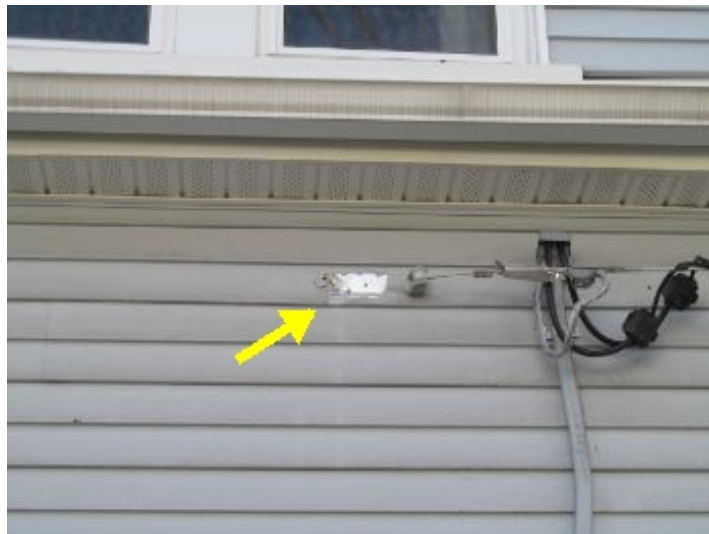
Damaged section of vinyl siding observed • Consult a siding contractor

Damaged section of vinyl siding observed

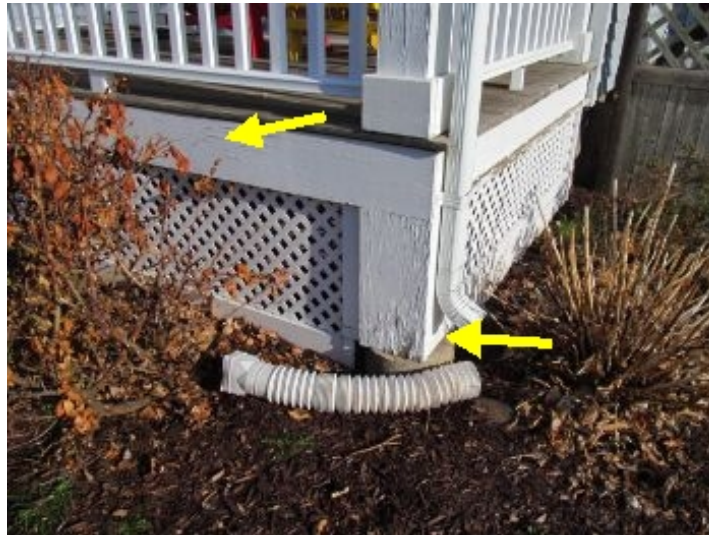
Weathered at front porch, recommend re painting to prevent damage to wood

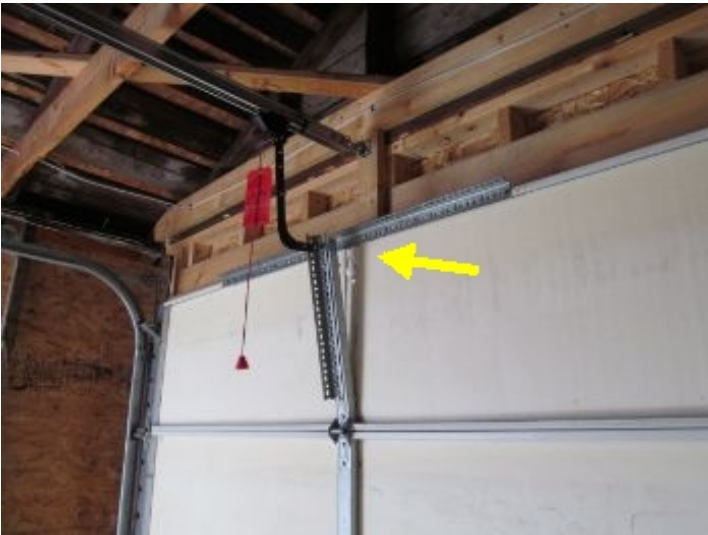
Damaged top door panel panel at right side door

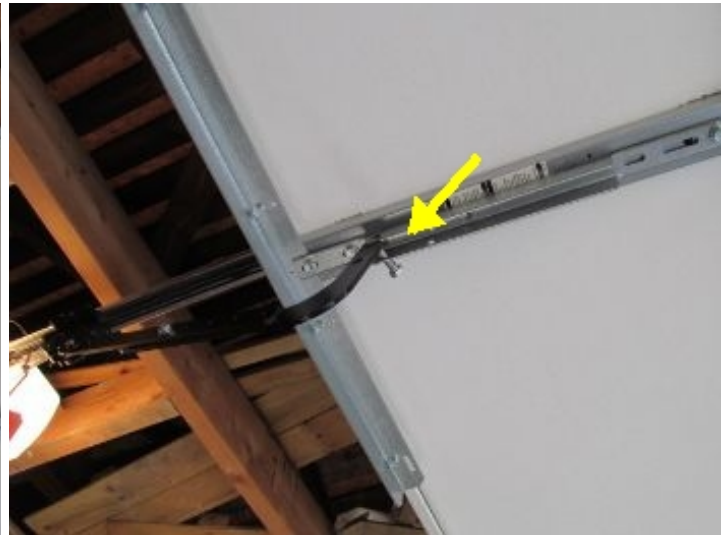
Loose bolt at left door
