Property Inspection Report

Sample report

Date of Inspection: 4/15/2015 Time: 12:30 Start, 3:15 finish

1986 home

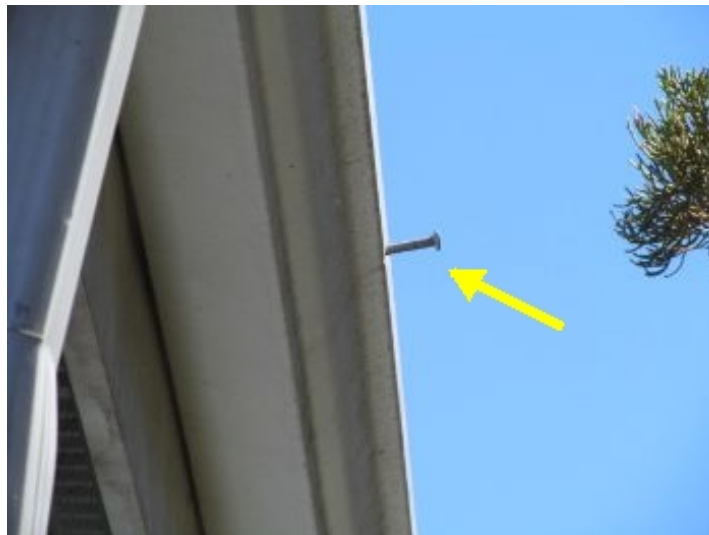
Gutter type: Aluminum
 Loose gutter nails at right side of garage

Loose gutter nails at right side of garage

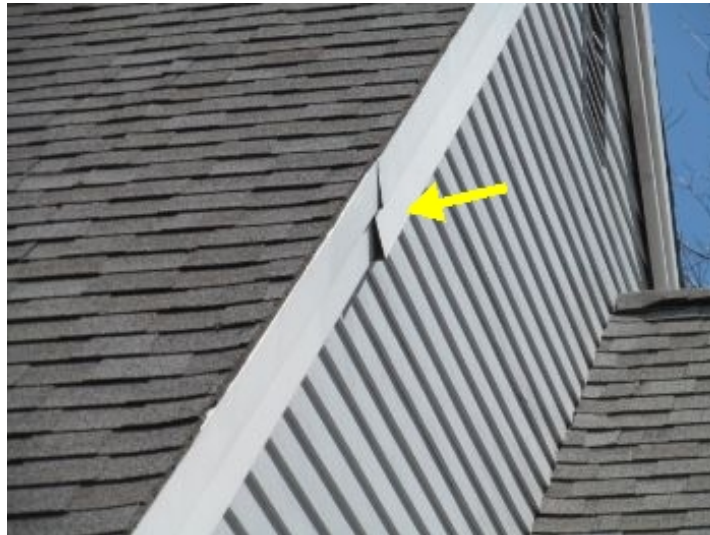
Loose fascia observed at right side rake trim

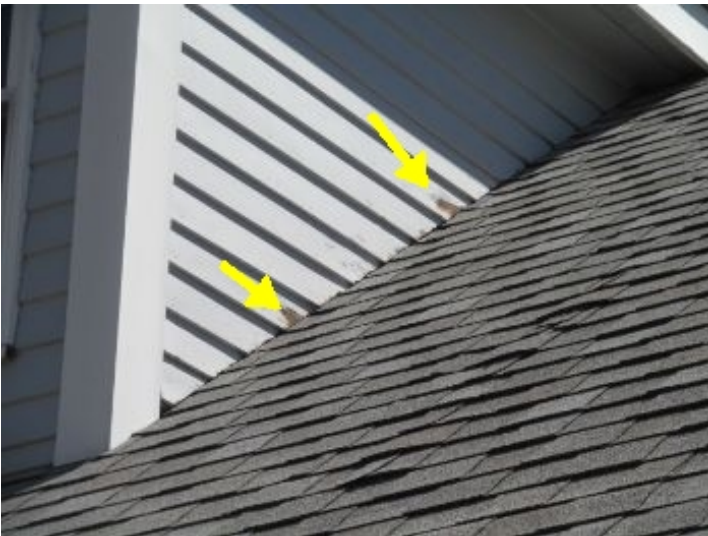
Deteriorated at roof contact points

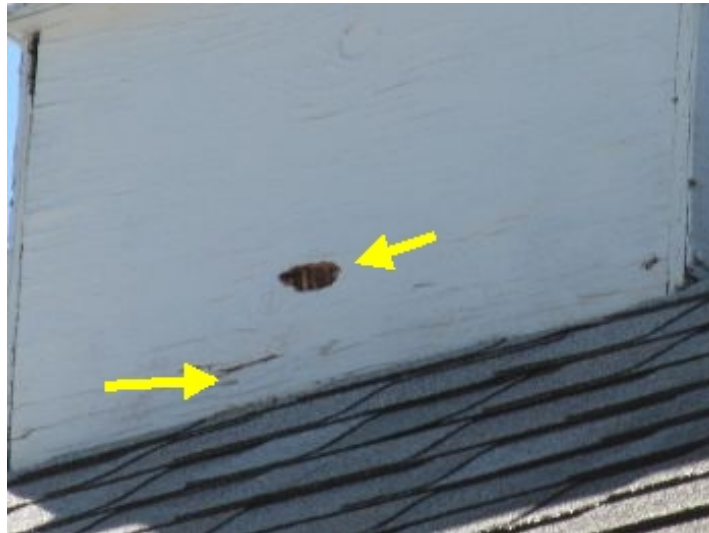
Rotted cupola

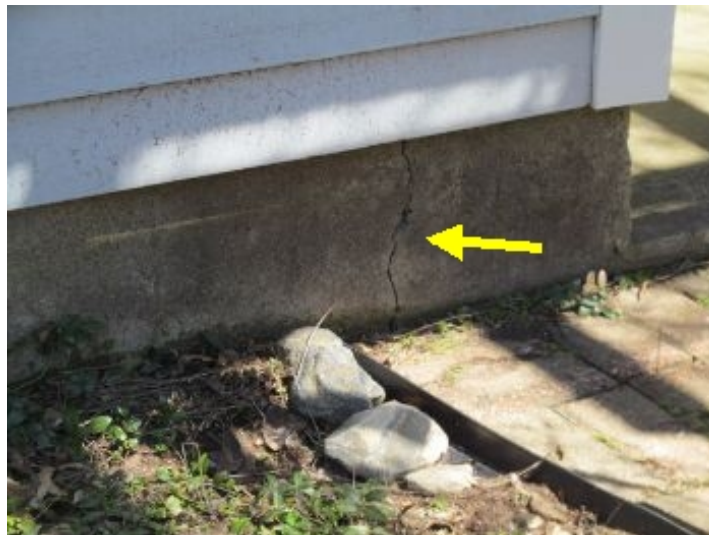
Crack observed at right side rear corner

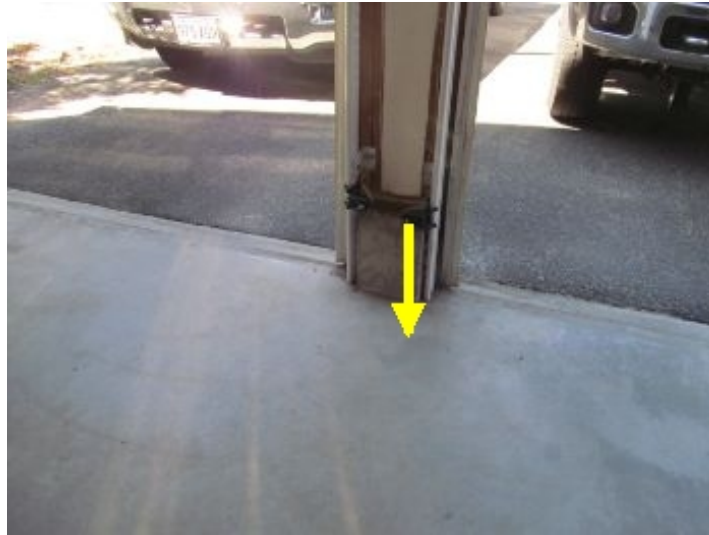
Type of door: Automatic door opener present • overhead doors
 Too much down force at left door, needs adjustment • Electric eye safety system improperly installed • Electric eye units too high, manufacturers recommend 6" from floor or less

Electric eye units too high, manufacturers recommend 6" from floor or less

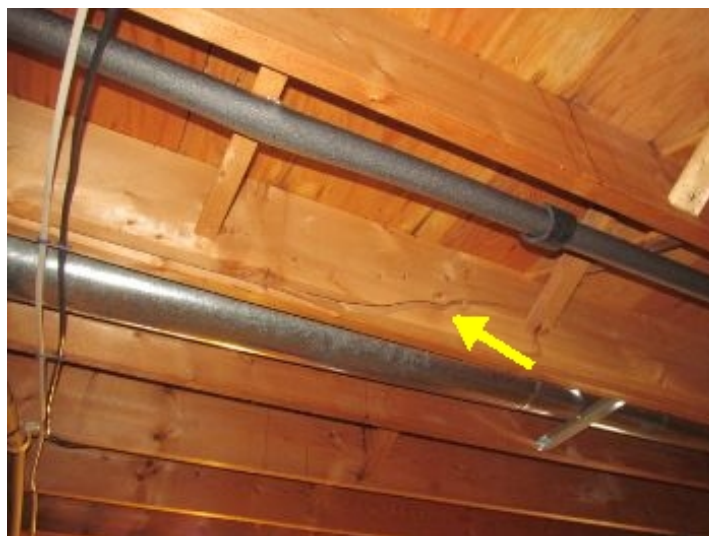
Broken joist observed but appeared to be sound because of additional joist along side

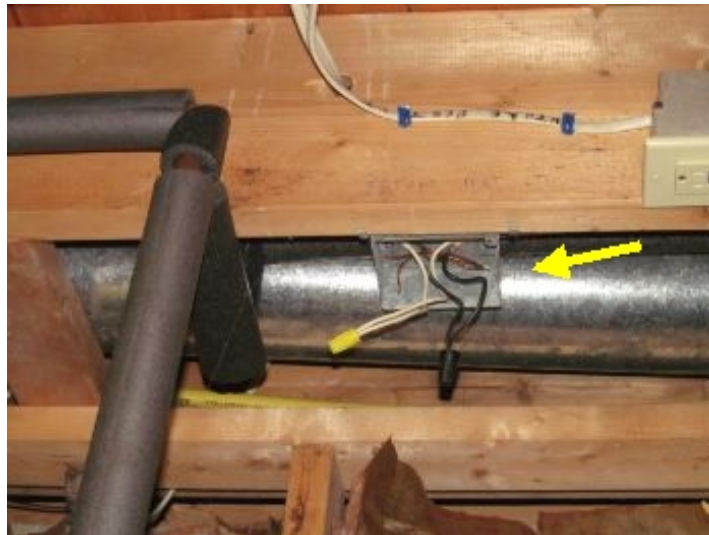
Missing electrical box cover

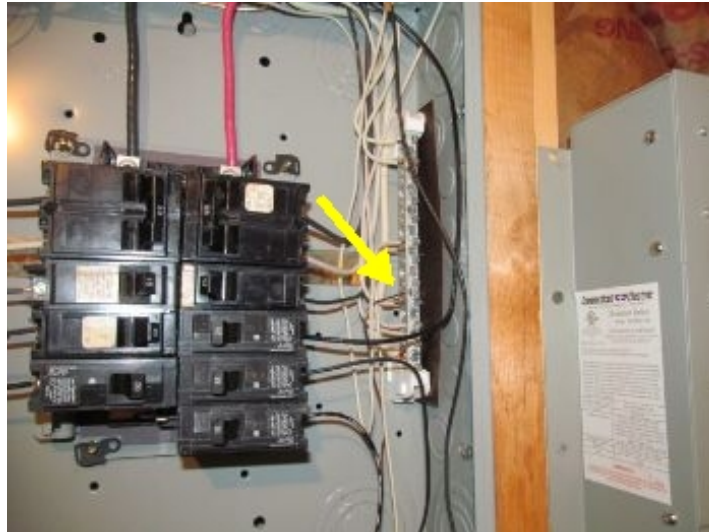
Panel and sub panel inspected • **Improper installation sub panel • Ground wire attached to neutral bus in sub panel • Consult a licensed electrician**

Ground wire attached to neutral bus in sub panel

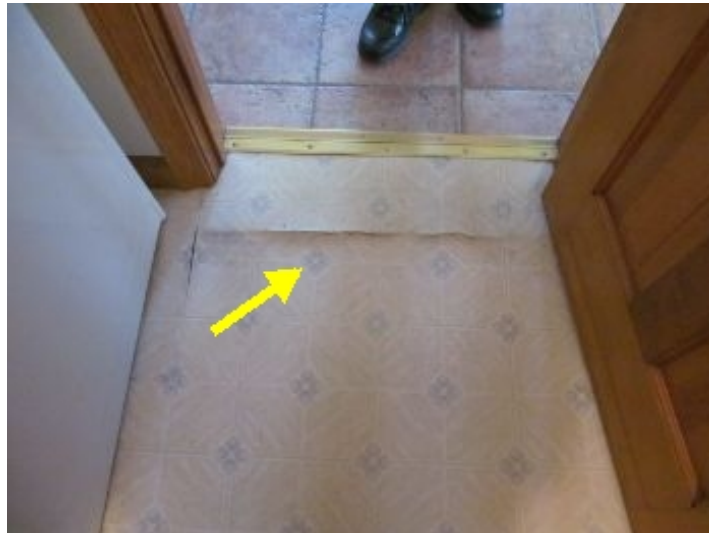
Cracks observed in concrete floor

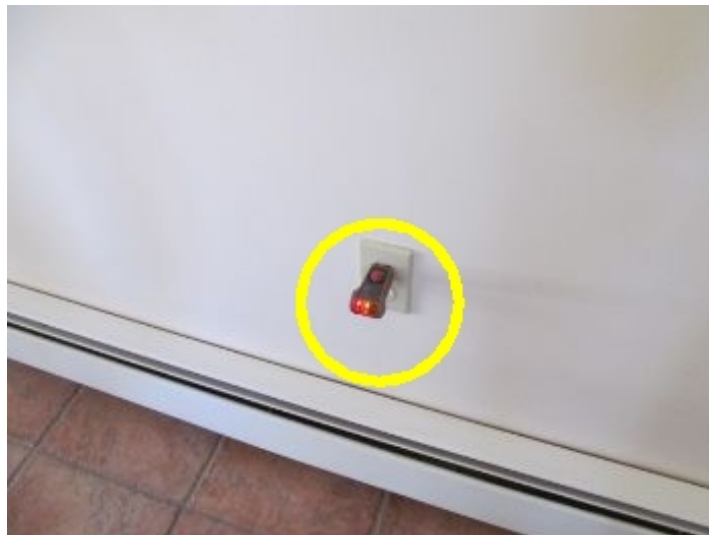
Hot & neutral reversed • Consult a licensed electrician

Hot & neutral reversed

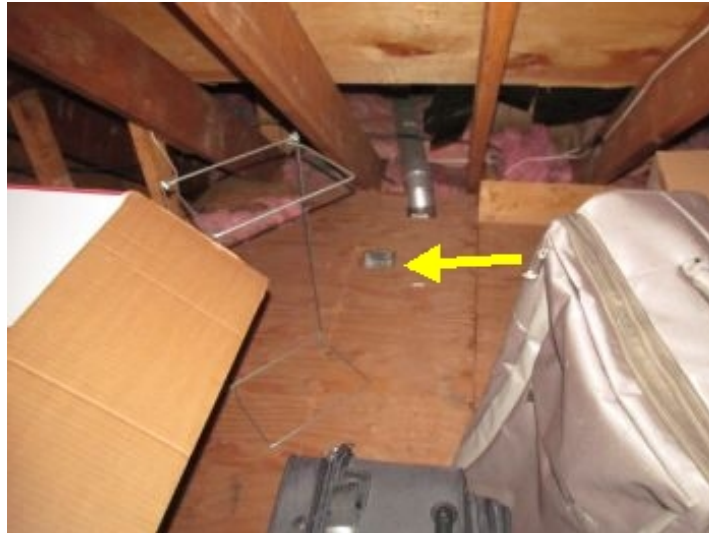
Missing electrical box covers
