Friendly Inspection Services

Property Inspection Report

Date of Inspection: 4/7/2015 Time: 8:45 Start, 11:00 finish

Age of Home: 1994

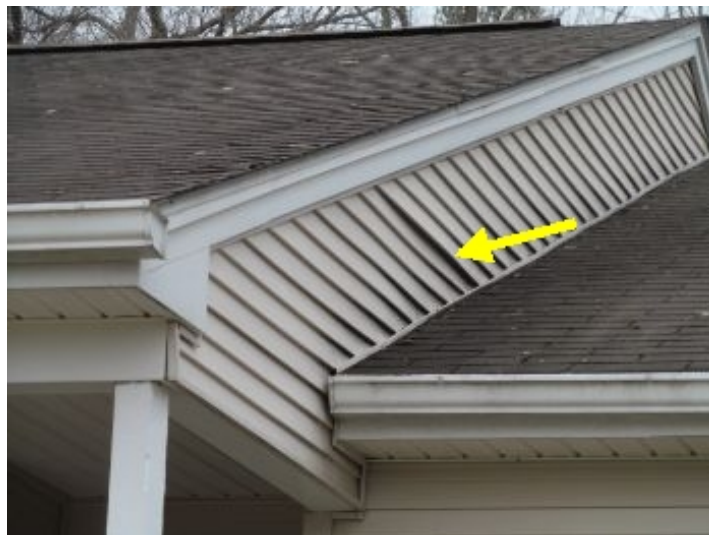
Siding type: Vinyl
 Loose siding observed

Loose siding observed

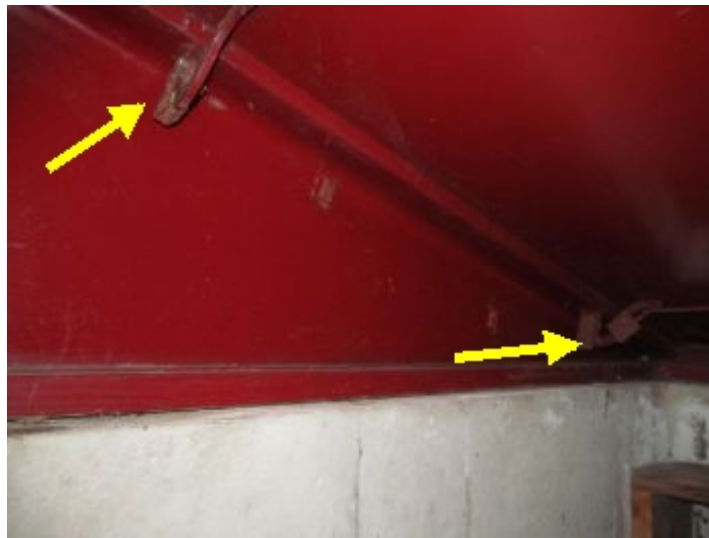
Bulkhead • Missing torsion springs

Missing torsion springs

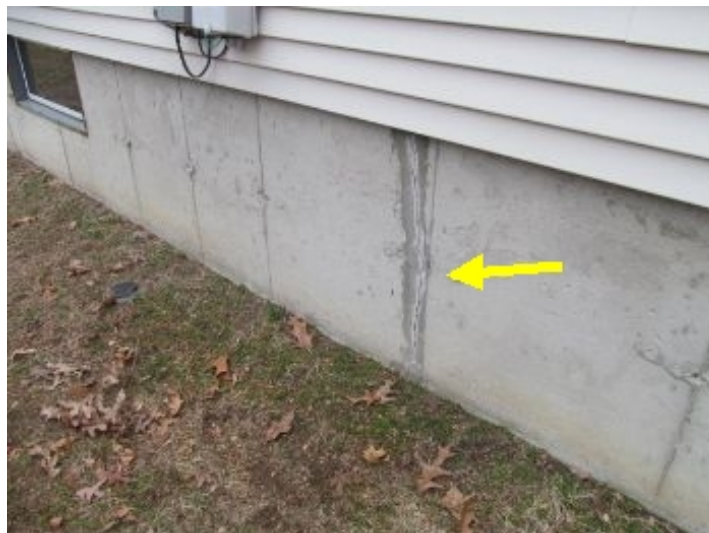
Foundation wall type: Concrete
 Floor type: Concrete
 Cracks observed • Cracks should be monitored for further movement

Cracks observed

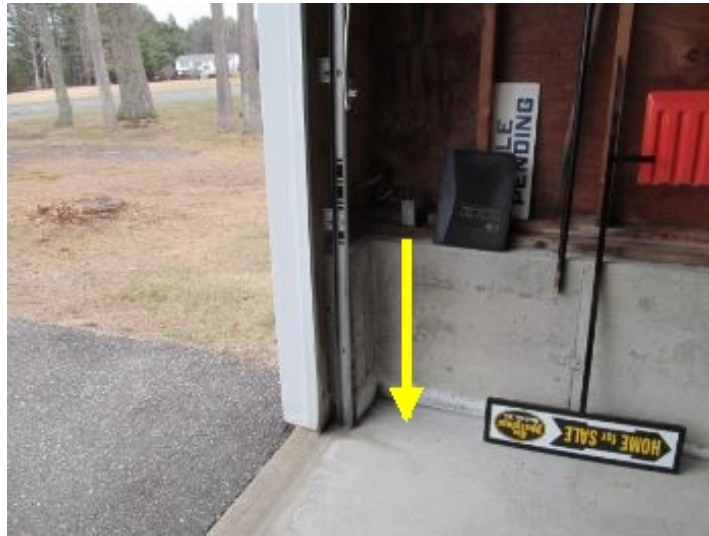
Type of door: Automatic door opener present • overhead door
Electric eye safety system improperly installed • Electric eye units too high

Electric eye units too high

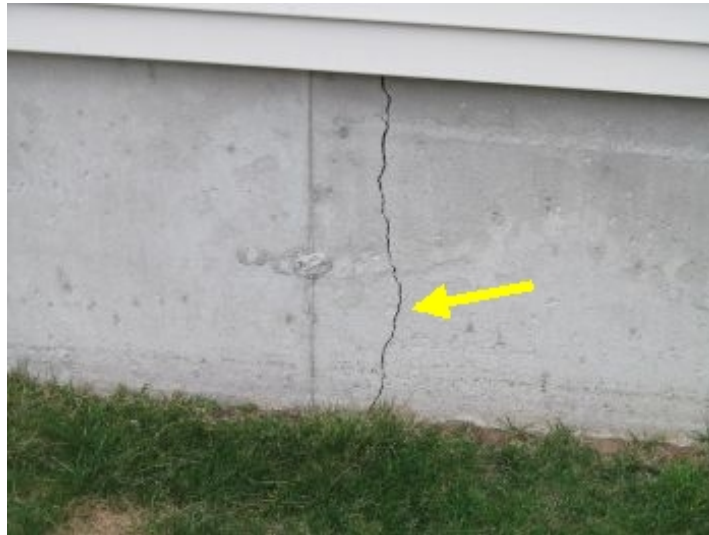
Type of foundation: Concrete
Cracks observed • Recommend sealing with polyurethane caulking to prevent water penetration

Cracks observed

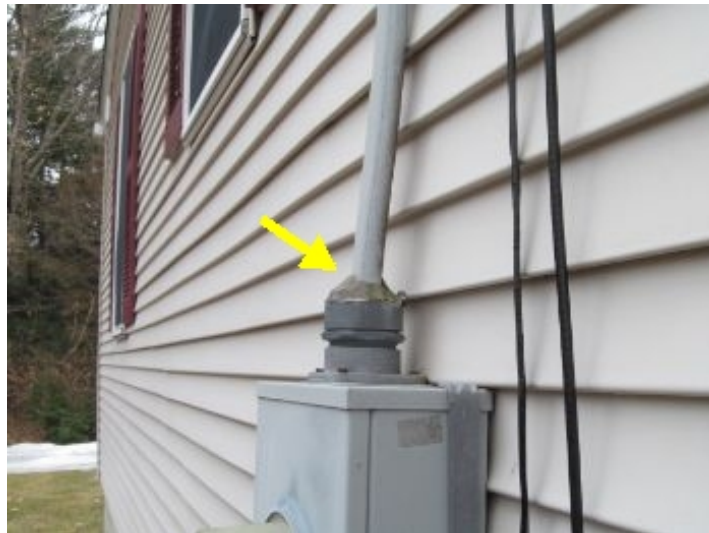
Service: Type: Aluminum, overhead service, drip loop, weatherhead, service entry cable, meter, inspected, **Cable entry into meter socket needs to be sealed properly , consult a licensed electrician**

Cable entry into meter socket needs to be sealed properly

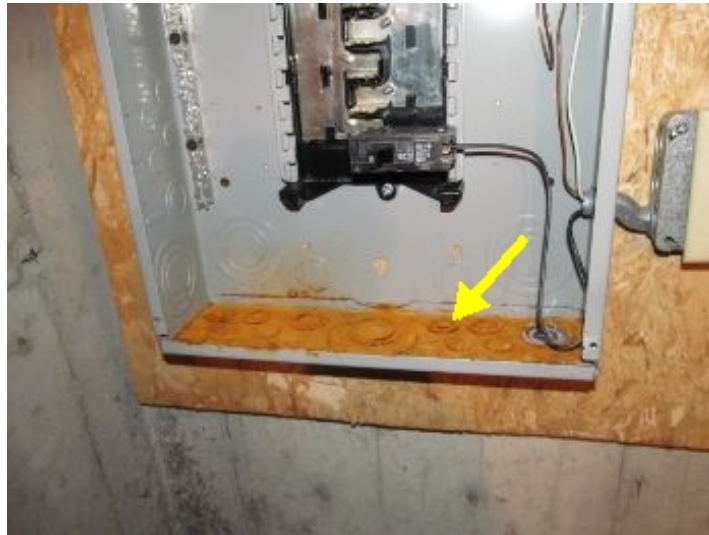
Amperage: 200 amp • 120 / 240 volt
 Location: Basement
Evidence of water in panel • Consult a licensed electrician

Evidence of water in panel

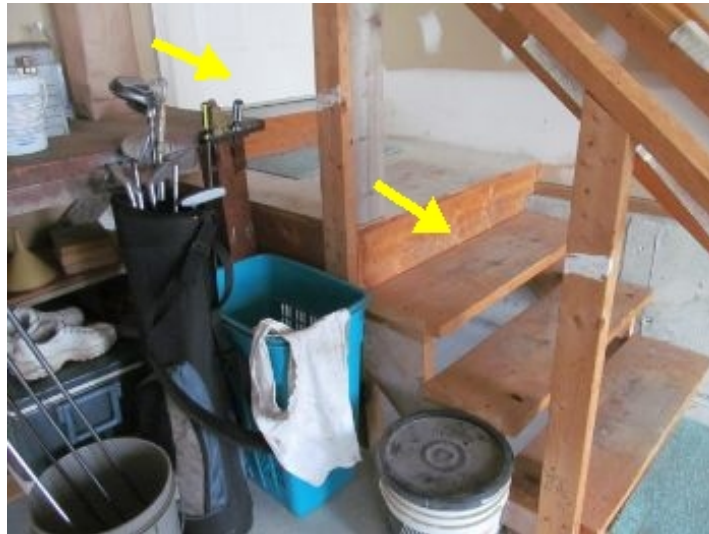
Garage stairs not child safe, require proper railings

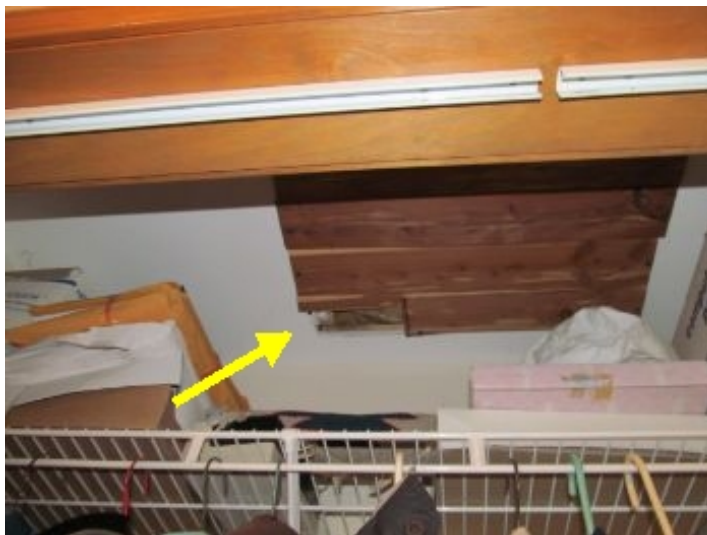
Walked in attic • **Recommend insulating and air sealing old scuttle cover**

Recommend insulating and air sealing old scuttle cover
